# RTSI Reliability Testing Services, Inc.

## Thermographic Report

Report Date: 12/03/2004

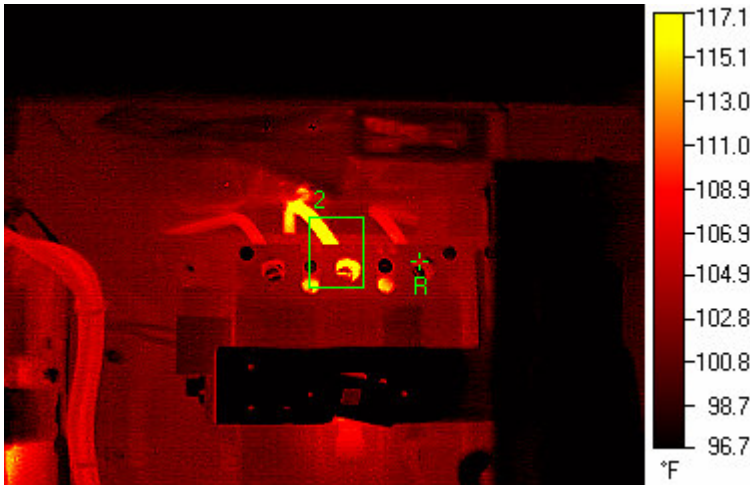
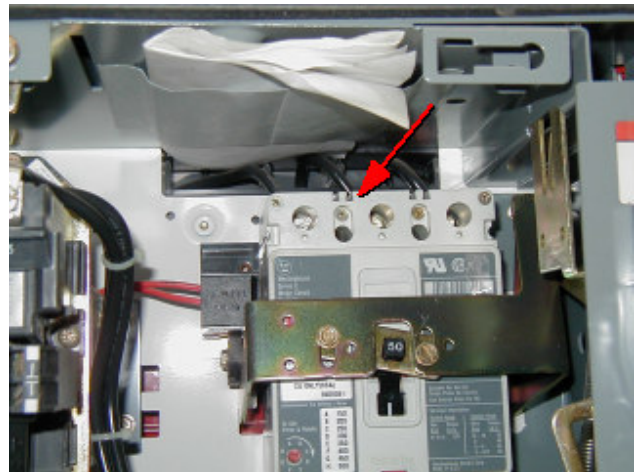
TH710004.SIT • 11/30/2004 • 9:02 AM

<b>Area:</b> Press	<b>Bucket #:</b> C2-3/03A
<b>MCC:</b>	<b>Equipment Name:</b> Negative Air Stacker Feeder Blower
<b>Equipment #:</b>	<b>Severity:</b> 2

Ref.	Rect2
Emiss.	0.9	0.9
Avg		114.9 °F
Min		103.2 °F
Max	112.6 °F	136.4 °F
<b>Delta</b>		<b>23.8 °F</b>

**Problem:** Phase 2 is heating at line side of breaker.

**Suggested Repair:** Clean, lube, and tighten connections. Remove all oxides from wiring and components.

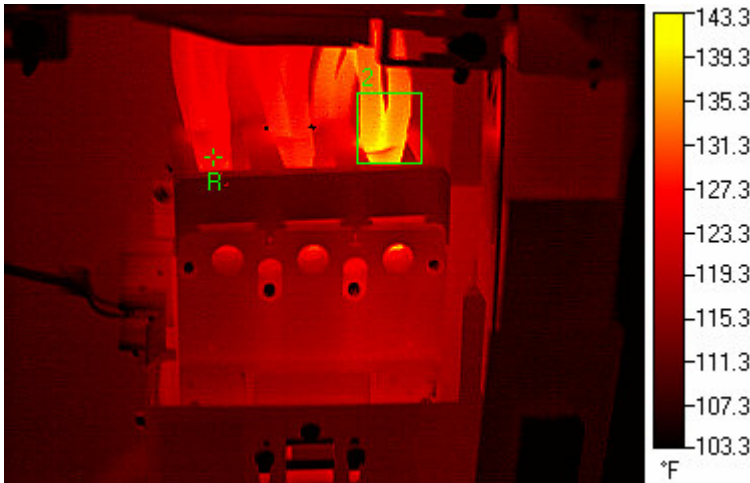
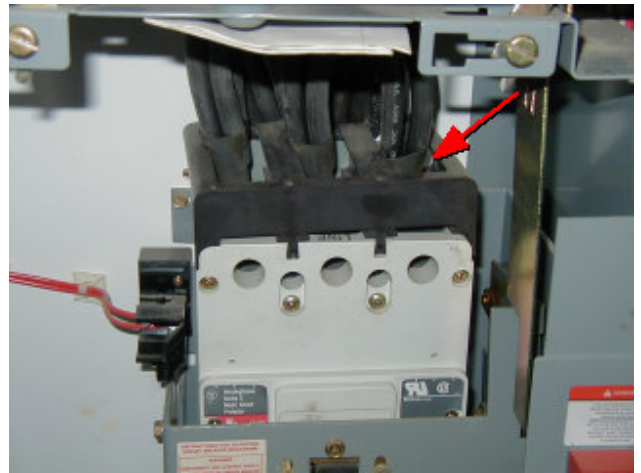
TH710005.SIT • 11/30/2004 • 9:13 AM

<b>Area:</b> Press	<b>Bucket #:</b> C1-2/03F
<b>MCC:</b>	<b>Equipment Name:</b> LP Pump No. 1
<b>Equipment #:</b>	<b>Severity:</b> 1

Ref.	Rect2
Emiss.	0.9	0.9
Avg		140.0 °F
Min		123.7 °F
Max	134.4 °F	150.3 °F
<b>Delta</b>		<b>15.9 °F</b>

**Problem:** Phase 3 is heating at line side of breaker.

**Suggested Repair:** Clean, lube, and tighten connections. Remove all oxides from wiring and components.

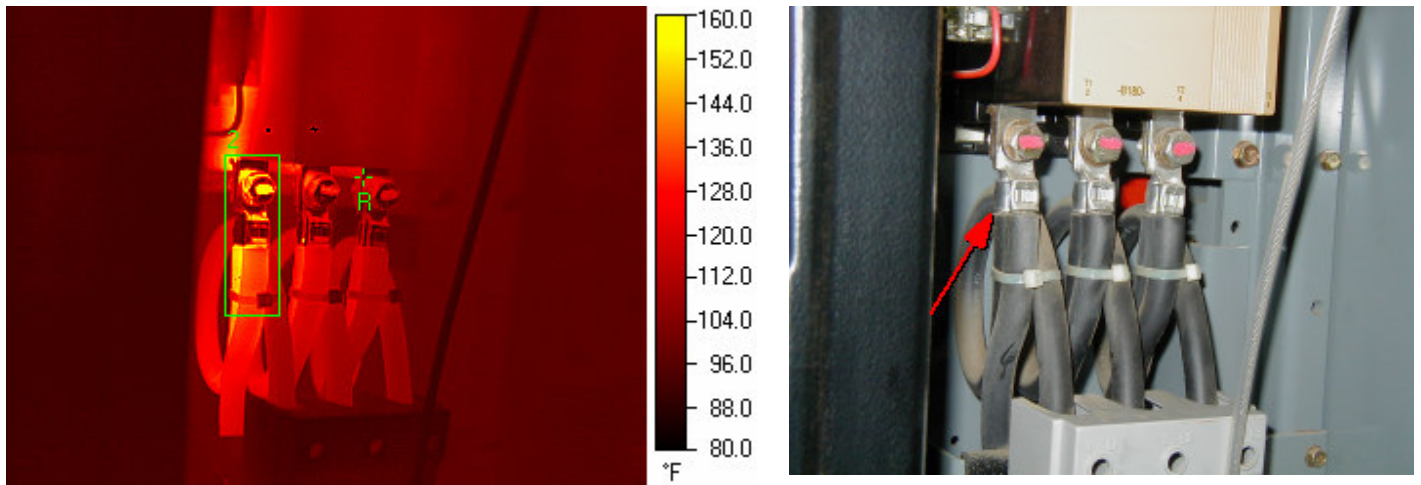
TH710006.SIT • 11/30/2004 • 10:26 AM

<b>Area:</b> Forming	<b>Bucket #:</b> C2-2/13A
<b>MCC:</b>	<b>Equipment Name:</b> Pneu. System E Main Blower
<b>Equipment #:</b>	<b>Severity:</b> 3

Ref.	Rect2
Emiss.	0.9	0.9
Avg		130.2 °F
Min		104.2 °F
Max	108.8 °F	174.3 °F
<b>Delta</b>		<b>65.5 °F</b>

**Problem:** Phase 1 is heating at load side of bottom contactor at rear wire.

**Suggested Repair:** Clean, lube, and tighten connections. Remove all oxides from wiring and components.

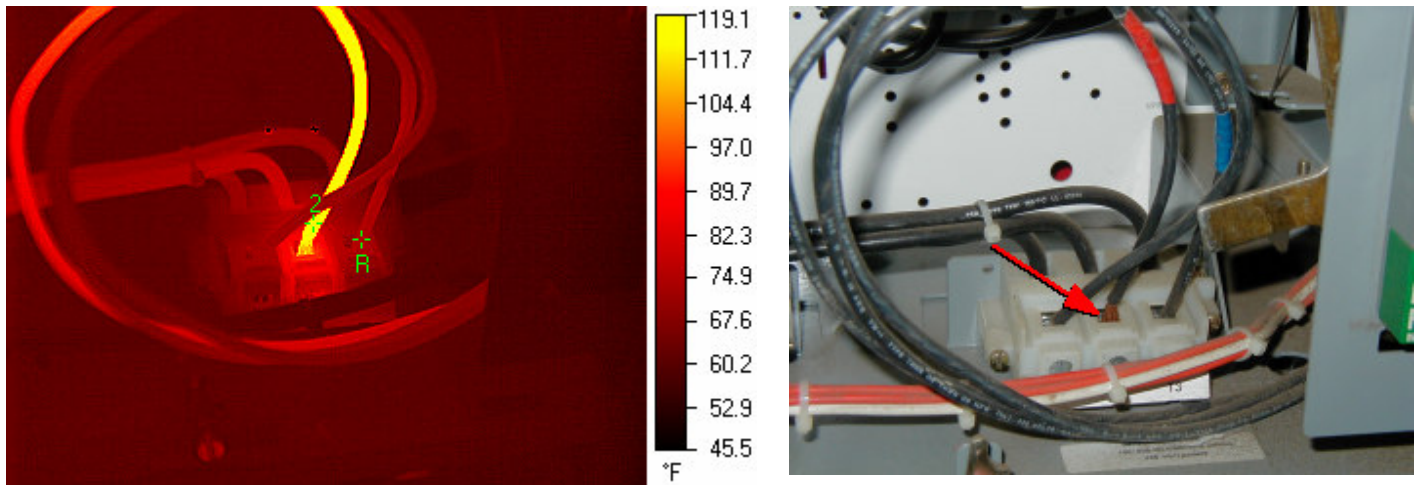
TH710007.SIT • 11/30/2004 • 11:01 AM

<b>Area:</b> Dryers	<b>Bucket #:</b> B3-3/10I
<b>MCC:</b>	<b>Equipment Name:</b> Gasifier Combustion Fan No. 1
<b>Equipment #:</b>	<b>Severity:</b> 2

Ref.	Point2
Emiss.	0.9	0.9
Avg		
Min		
Max	79.2 °F	129.3 °F
<b>Delta</b>		<b>50.1 °F</b>

**Problem:** Phase 2 is heating at T lead terminal block.

**Suggested Repair:** Clean, lube, and tighten connections. Remove all oxides from wiring and components.
