Thermal Problem Details Report

Site: Store 771-Atlanta

Location: 1st Floor Group 1SW

Equipment: DP-4

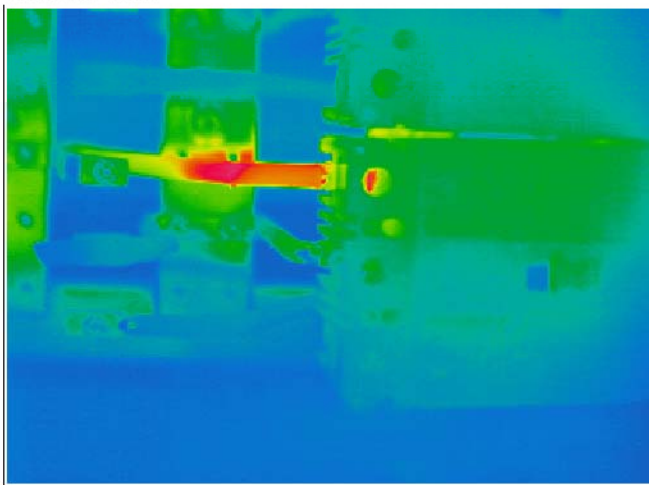
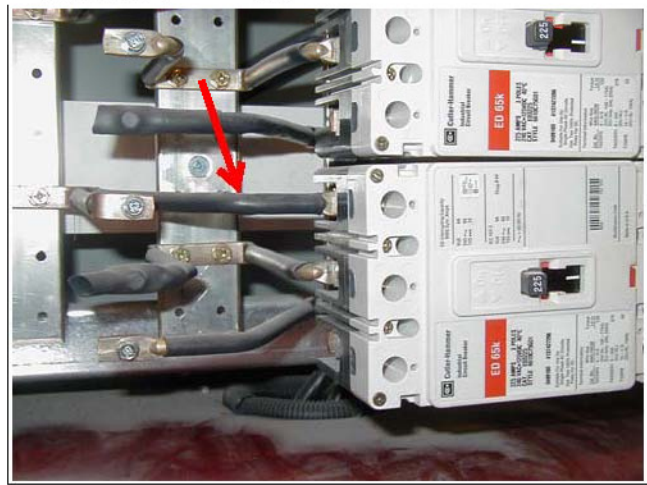
Inspection # 1	Problem # 1
Problem Date/Time: 2/16/2005 11:01:46 AM	
Indirect Temp. Measurement: No	
Component Temp: 110 @ 2%	
Reference Temp: 81 @ 8%	
Temp Rise: 29 @ 2%

Component: A phase (top) buss is heating at line side of feeder breaker 1M1.

Probable Cause: Stressed and/or cracked buss.

Type of defect found: Stress point where buss bend was formed.

Recommendation: Clean, lube, and tighten connections. Replace buss piece.

Corrective action taken: Buss was replaced on inspection date. Problem area was re-tested and found to be repaired.
