Location: Brine Tank

Equipment: Brine Tank--SE Side at drain valve

THERMOGRAPHIC REPORT

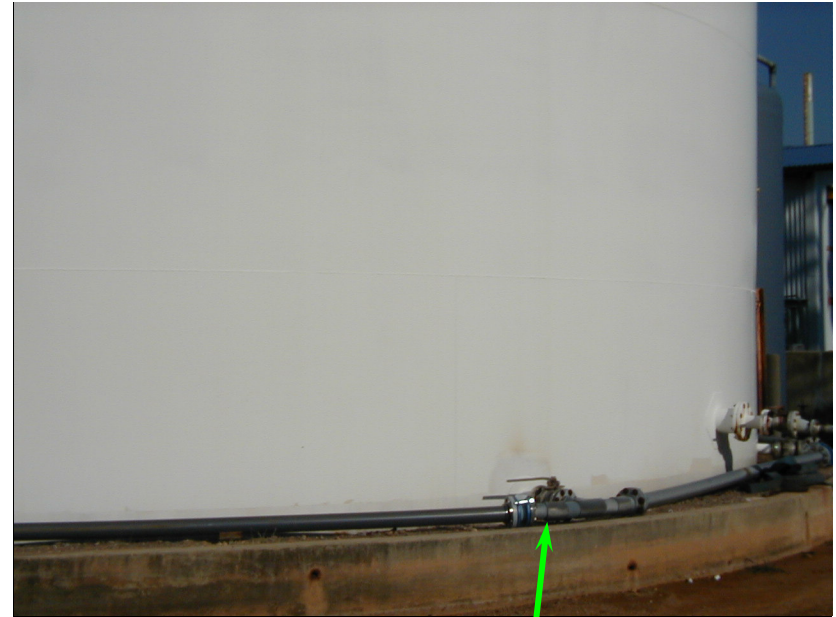
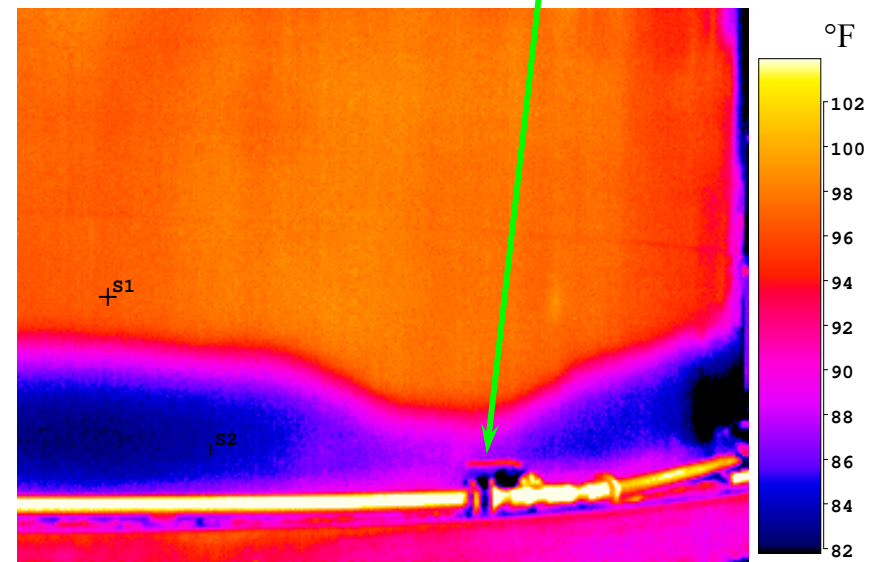
49300004.IRI					
ITEM	TYPE	AVG TEMP	MAX TEMP	MIN TEMP	EMISS
Whole Image	Image	94.15	119.14	72.89	0.92
S1	Spot	96.67	97.55	95.76	0.92
S2	Spot	83.64	84.41	83.04	0.92

Observation: Sludge is built up to approximately 3' around the circumference of the tank. The "dips" in the sludge level are where the drain valves are located.
