RTSI

Location: Paper Machines

Equipment: # 1 A Broke Tower Agitator

Thermography Report

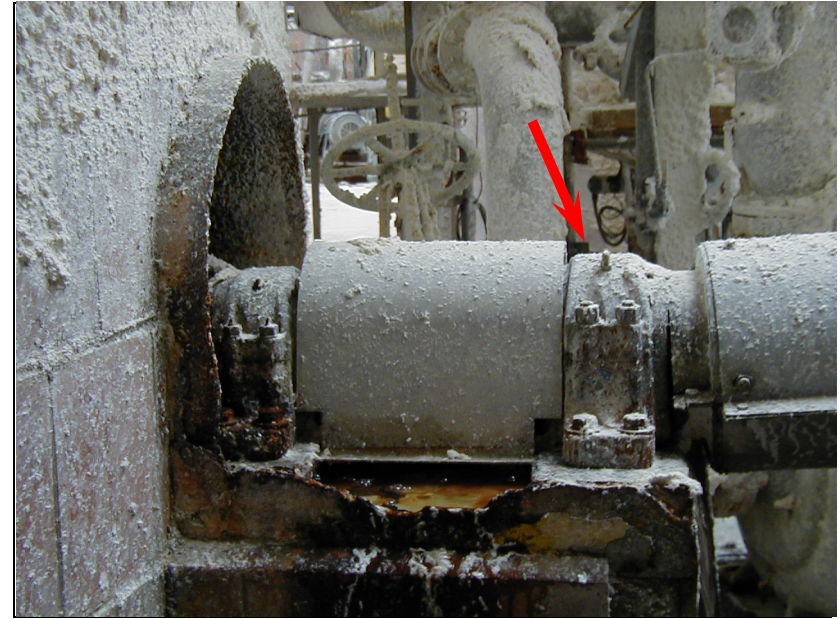
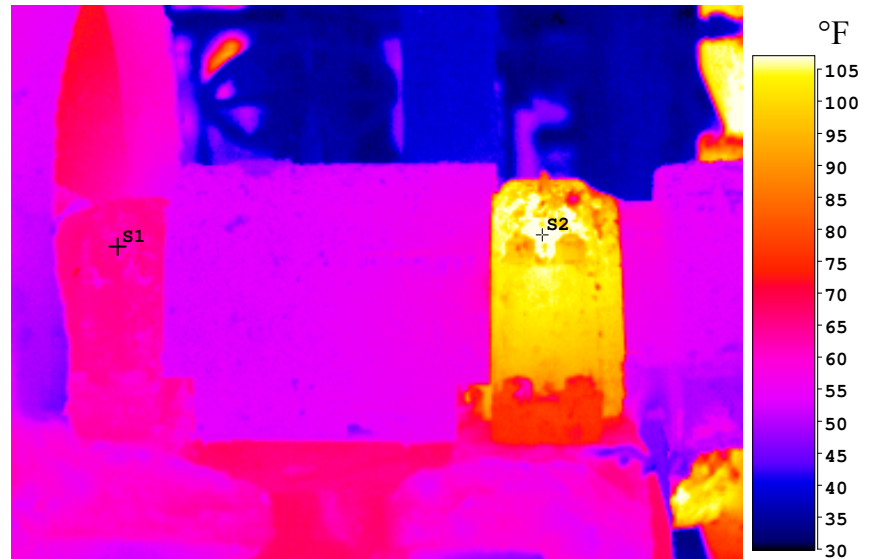
43070006.IRI					
ITEM	TYPE	AVG TEMP	MAX TEMP	MIN TEMP	EMISS
Whole Image	Image	56.95	112.21	29.83	0.92
S1	Spot	62.96	64.38	60.37	0.92
S2	Spot	109.66	112.21	107.43	0.92

Problem: Bearing next to motor shows a temperature rise.

Rise: 48

Recommendation: Check lubrication, check with vibration analysis for possible bearing anomaly. Continue to monitor.
