Thermal Problem Details Report

Site: Store 771-Atlanta

Location: 1st Floor Group 1SW

Equipment: DP-4

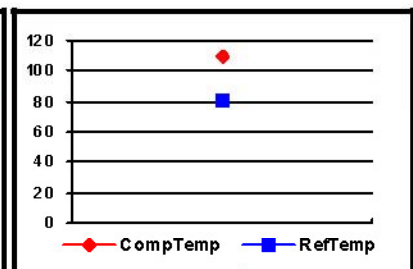
Component: A phase (top) buss is heating at line side of feeder breaker 1M1.

Probable Cause: Stressed and/or cracked buss.

Type of defect found: Stress point where buss bend was formed.

Recommendation: Clean, lube, and tighten connections. Replace buss piece.

Corrective action taken: Buss was replaced on inspection date. Problem area was re-tested and found to be repaired.
